**INVESTIGATION INTO
THE MERCURY SPILL OF JUNE 2, 2000
IN THE VICINITY OF
SAN JUAN, CHOROPAMPA,
and MAGDALENA, PERU**

July 2000

Report of the Independent Commission
to the Office of Compliance Advisor/Ombudsman
of the International Finance Corporation and
the Multilateral Investment Guarantee Agency

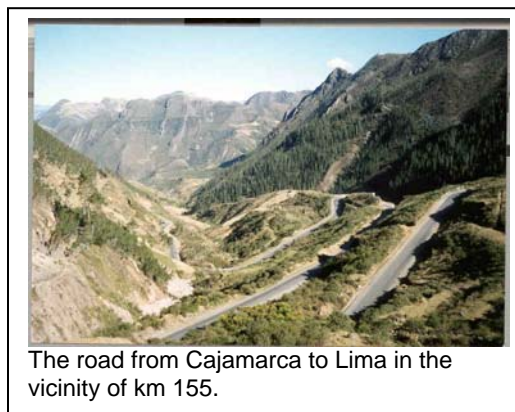
The road from Cajamarca to Lima in the vicinity of km 155.

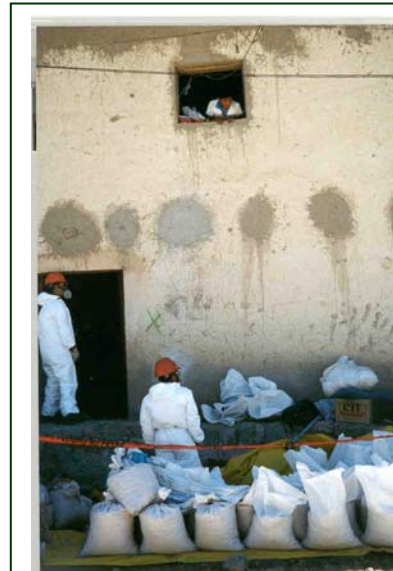
Soil floor being excavated from a house while young boy watches

Clothing and personal belongings of the residents were also examined for potential mercury contamination using one of the Lumex air monitors. Contaminated belongings or foodstuffs were immediately removed. All contaminated materials including soil from the homes and roads were placed in bags and transported back to the mine site for storage.

It is difficult to ascertain the exact status of the air quality-monitoring program, as it is an on-going exercise. However, MYSRL reports indicate that by the end of July approximately 67 homes within Choropampa alone had been identified to contain some level of mercury contamination (e.g. Level 1,2 or 3) with another 143 homes considered “clean” as follows:

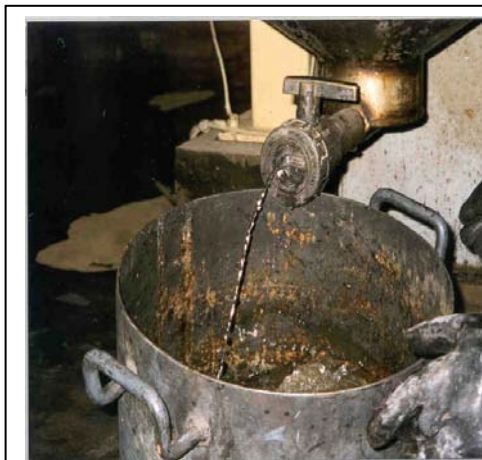
Elemental mercury collected from retorts in the refinery.

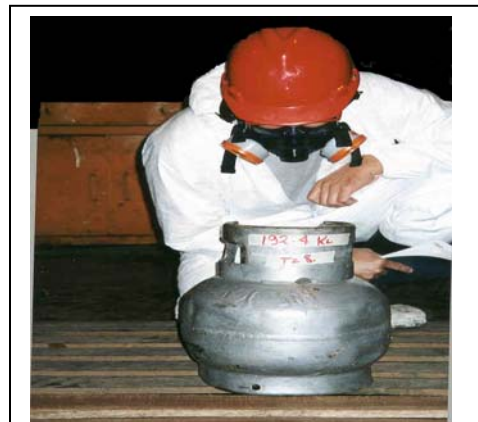
Filled flask of mercury with recorded weight.

The Independent Commission observed during its visit to the mine property in July 2000 that the filled mercury vessels were not labeled, as required by IFC.

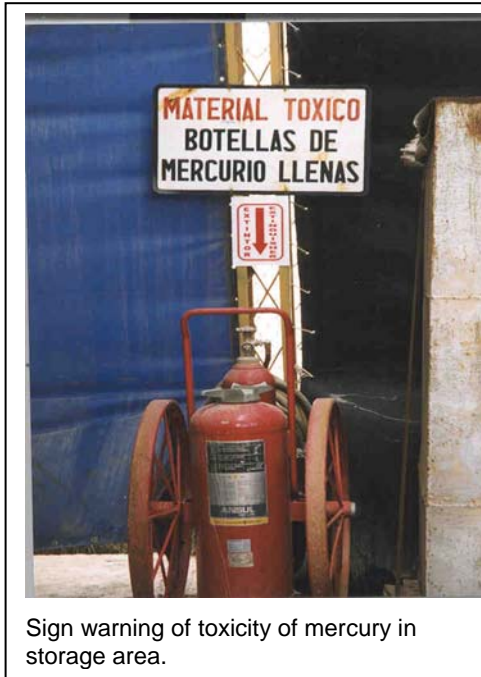
Sign warning of toxicity of mercury in storage area.

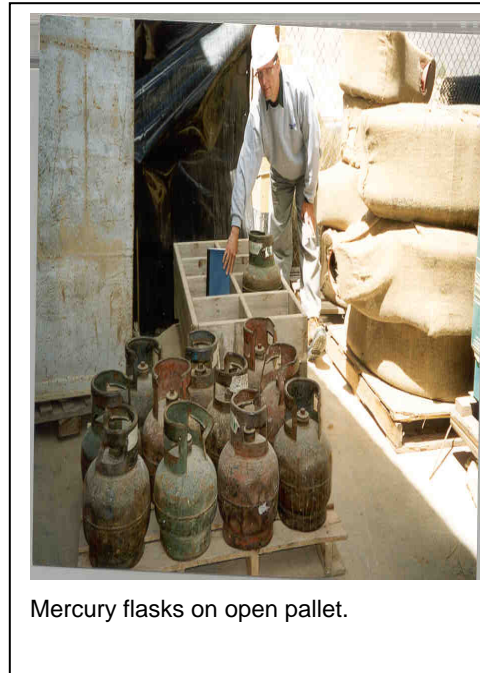
Mercury flasks on open pallet.

The pallet of mercury containers was placed at the rear of the trailer. It was acknowledged that they should have been placed close to the truck, which was the accepted, even if informal, practice. It was acknowledged that the warehouse supervisor had some weeks before insisted that a shipment of mercury be removed from a similar truck and trailer due to its improper positioning.

The Independent Commission was told by both RANSA and MYSRL that a closed container was generally preferred for the shipment of mercury. This would infer that both firms understood that a closed container was more appropriate for the shipment of mercury. Upon closer examination, however, it was apparent that open flat bed trucks were used with the same frequency as closed trucks. At the same time RANSA officials maintained they were not even aware that mercury (a hazardous material) was being shipped on their trucks. This seems highly unlikely since the practice had been ongoing for years and mercury was clearly
